AFFIDAVIT OF KURT D MULDER, P.E.

FROM: Kurt D. Mulder, P.E.

REFERENCE: Roof Evaluation – Haman, Inc. dba Knights Inn
D.o.I.: April 28, 2014
L.o.I.: Bessemer, Alabama
Chubb Claim Number: WKFC-5689A9
York File Number: YKFA-025719
ED&T File Number: BHM7344-92202

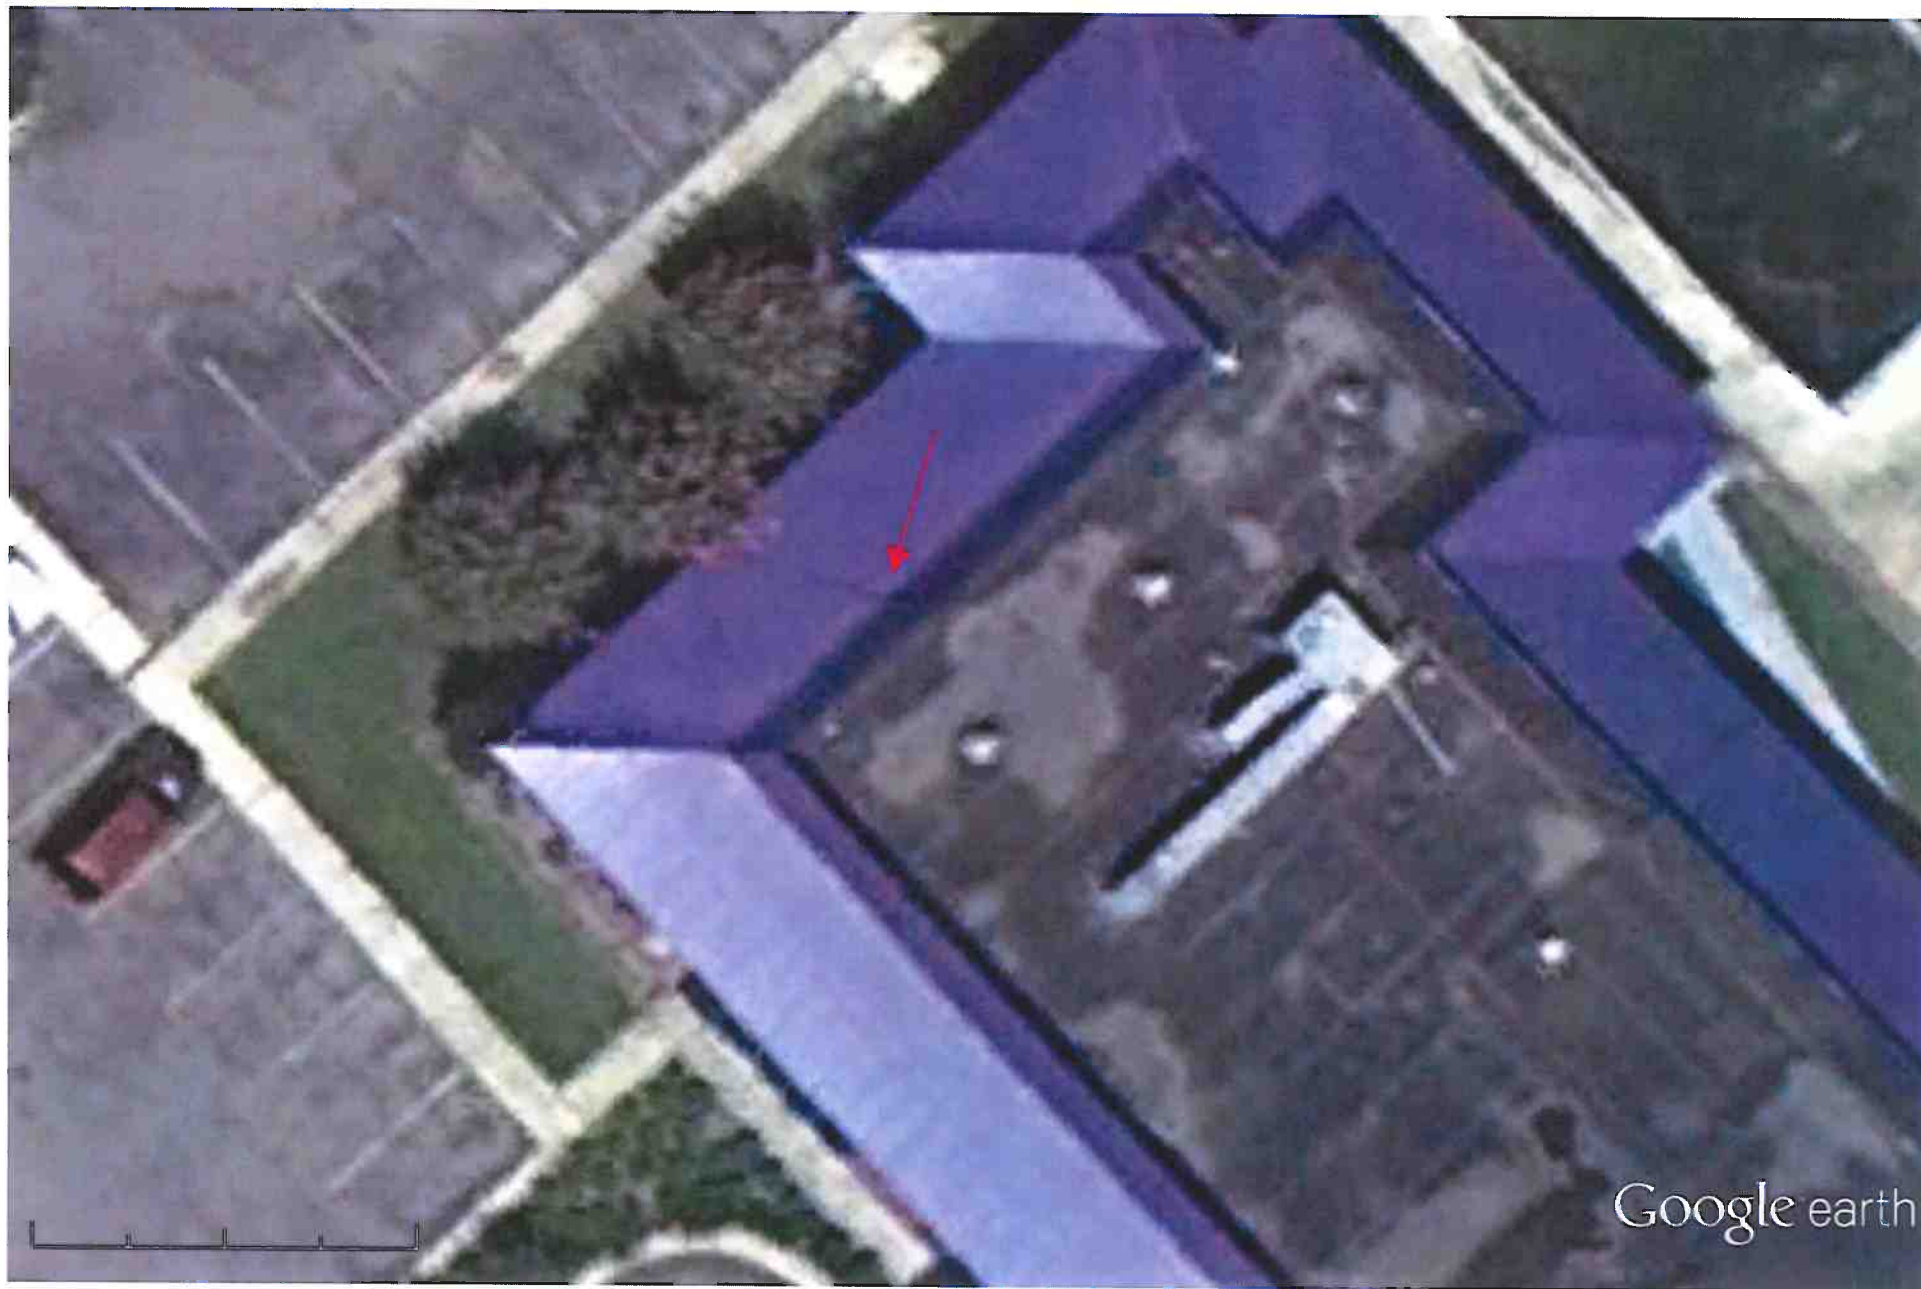
Aerial Photograph, September 4, 2010,
Knights Inn, Bessemer, Alabama

Google Earth historical and aerial photos taken on September 4, 2010 (Appendix IV to my report) show that a piece of coping was coming off the roof of Building A. This pre-dated the 2014 tornado by approximately four years, and establishes that this damage to the roof pre-existed the tornado.
